**SVA-S/L, SVA-ST/LT, SVA-HS, SCA/X size 100**

Repair kit | Code number 148B6066

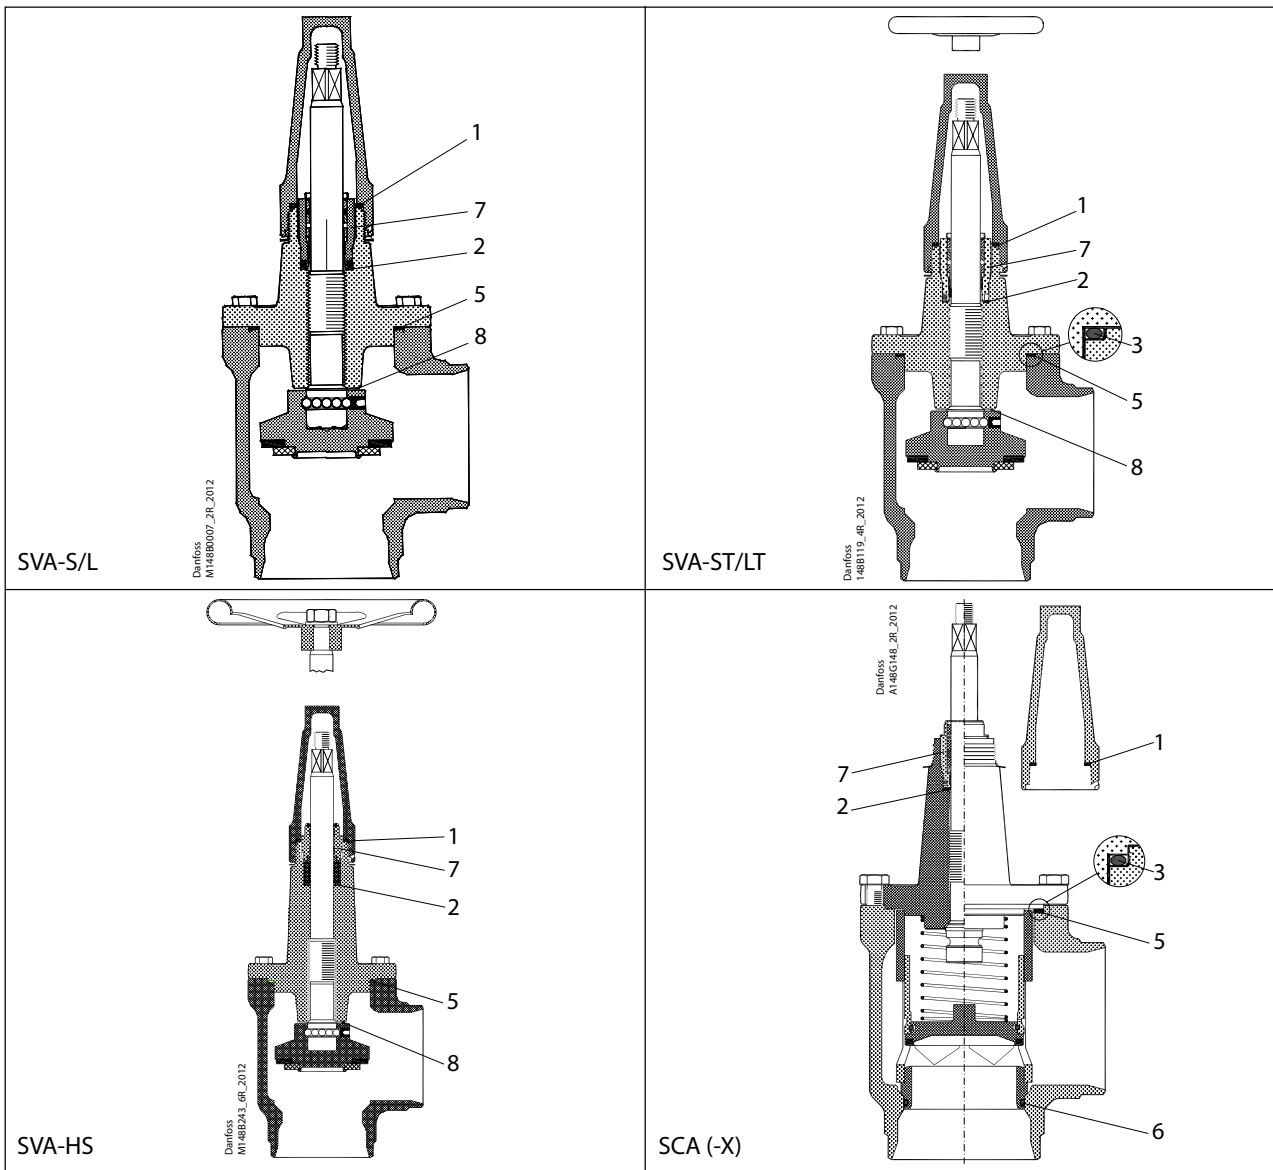
<p><b>1</b></p> <p> = Nylon</p> <p>Total no. = 1</p>	<p><b>2</b></p> <p> = Alu.</p> <p>Total no. = 1</p>	<p><b>3</b></p> <p>Total no. = 1</p>	<p><b>5</b></p> <p> = Fibre</p> <p>Total no. = 1</p>	<p><b>6</b></p> <p>Total no. = 1</p>
<p><b>7</b></p> <p>Total no. = 1</p>	<p><b>8</b></p> <p> = PTFE</p> <p>Total no. = 1</p>

When replacing the packing gland (pos. 7) in SVA-ST, SVA-S/L, SVA-HS, SCA-X and SCA the aluminium gasket (pos. 2) is needed.
