SVA-S/L, SVA-ST/LT, SVA-HS, SCA/X size 80

Repair kit | Code number 148B6065

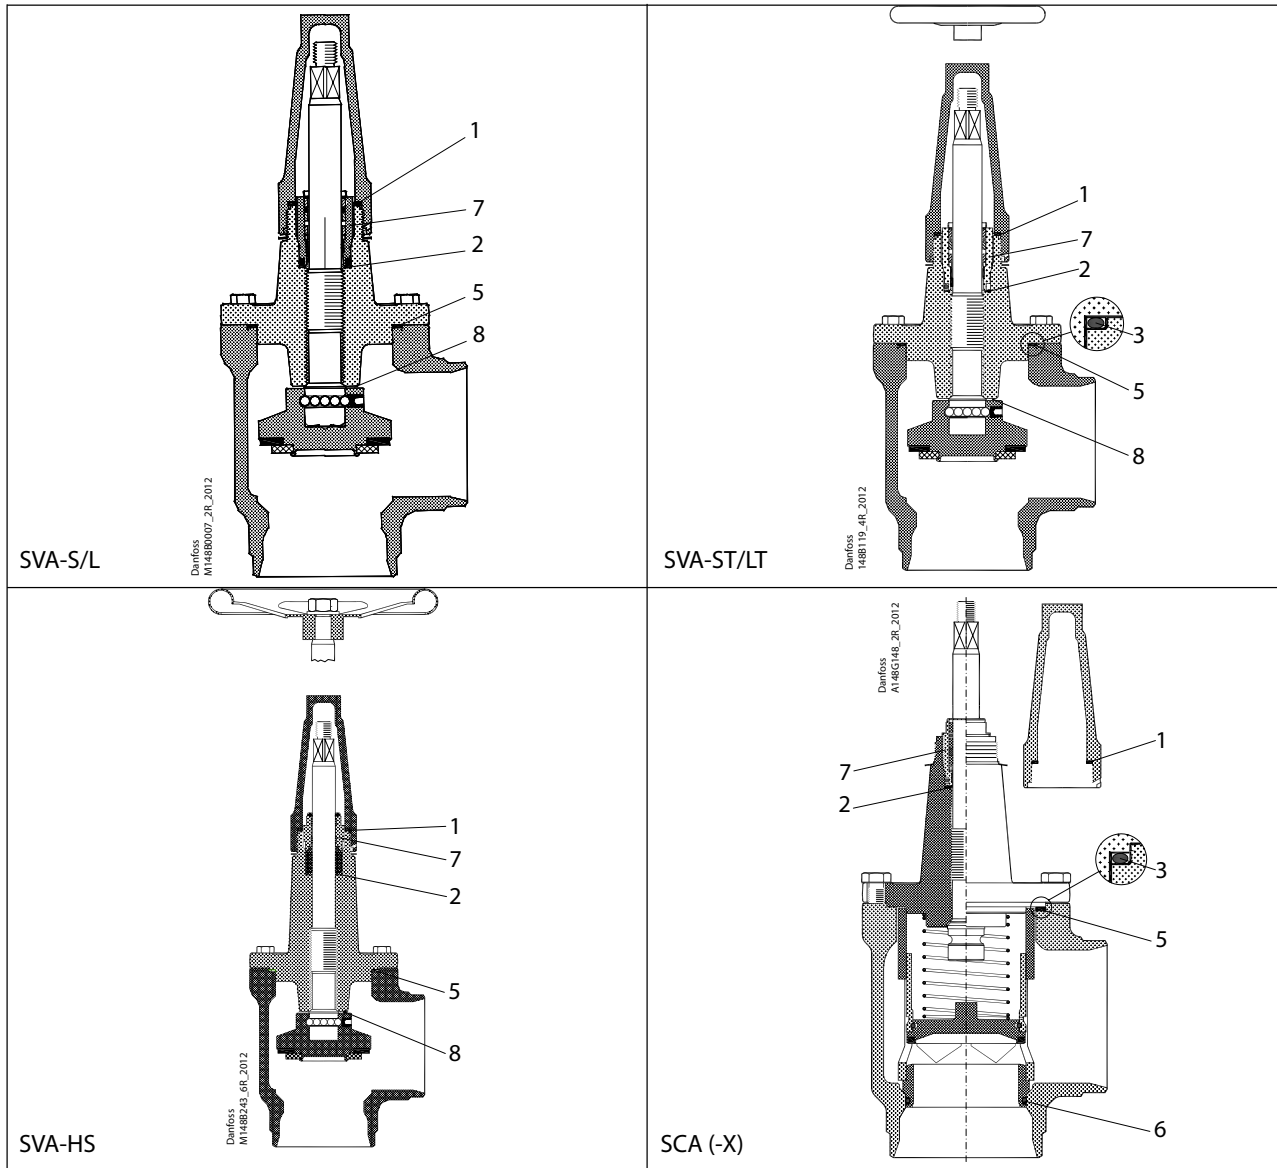
<p>1</p> <p> = Nylon</p> <p>Total no. = 1</p>	<p>2</p> <p> = Alu.</p> <p>Total no. = 1</p>	<p>3</p> <p>Total no. = 1</p>	<p>5</p> <p> = Fibre</p> <p>Total no. = 1</p>	<p>6</p> <p>Total no. = 1</p>
<p>7</p> <p>Total no. = 1</p>	<p>8</p> <p> = PTFE</p> <p>Total no. = 1</p>

When replacing the packing gland (pos. 7) in SVA-ST, SVA-S/L, SVA-HS, SCA-X and SCA the aluminium gasket (pos. 2) is needed.
